THERMAL CONDITIONS IN THE BATHROOMS OF THE ELDERLY IN SUMMER, AUTUMN AND WINTER IN JAPAN

T. Ohnaka

Fukuoka Women's University, Fukuoka, Japan

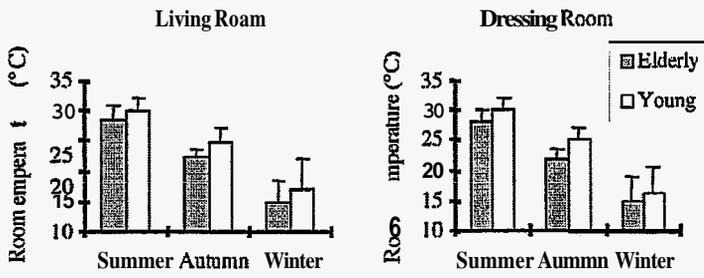
Figure 1 shows the air temperatures in the living rooms and dressing rooms in the three seasons. The living room temperature represented the temperature when subjects were resting there just before taking a bath. The dressing room temperature is given when the subjects undress. In summer and autumn, significantly higher room temperatures in both rooms were found in the young persons' houses. On the other hand, there were no significant differences in rooms between the groups in winter. The mean temperatures (SD) in the dressing rooms in winter were 15.1 (3.8)°C in the elderly and 16.1 (4.5)°C in the young, respectively. Some cases with air temperatures at 10°C or below were observed in the elderly persons' houses. However, one-third of the elderly did not perceive it as "cold" when air temperature was at 15°C or below in the dressing room after taking off their clothes.

Figure 1. Room temperatures in living room (left) and dressing room (right) in the three seasons. Values are means \pm SD.

The room temperatures were around 30°C in summer and 15°C in winter (Figure 1), which is quite different from the standards or recommendations for thermal environmental conditions for occupancy (4). In this survey, all houses were equipped with air conditioner and/or heater in the living room. However, they were used for very short duration, i.e., mealtimes. As a result, the indoor temperature did not reach the standards. Tochiyama and Ohnaka (5) surveyed the thermal conditions in Tokyo and reported that the average (SD) room temperatures at 7:00 PM of the houses of the elderly and the young were 15.6 (4.8) $^{\circ}\text{C}$ and 18.1 (3.9) $^{\circ}\text{C}$, respectively. They were similar to those in this study and lower by 4 to 5°C than those in USA (6).

In this survey, there were no air conditioners or heaters in the dressing rooms. The room temperatures in the dressing rooms were lower than those in the living rooms (Figure 1). Some elderly did not feel cold at 15°C and below after taking off their clothes in the dressing room. The reason heaters are not installed in the bathrooms might be not only economic but the result of a diminished sensitivity to cold found in elderly persons (7).

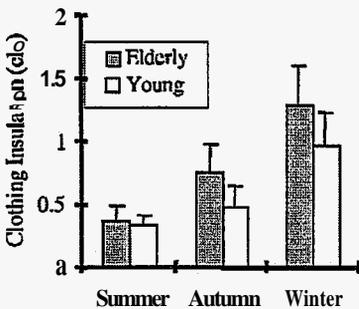
Figure 2 shows the insulation of clothing worn in the living room just before taking a bath. Clothing insulation was significantly higher for the elderly in winter compared with the young. In autumn and summer, there were no significant differences between the groups.

Figure 2. Clothing insulation in the three seasons.

The elderly dressed warmer than the young in winter (Figure 2), and there was a significant difference in the relationship between living room temperature and clothing insulation (Figure 3). The lower room temperature in the houses of the elderly and use of warmer clothing under cool conditions were also reported by Tochiyama and Ohnaka (5). Elderly Japanese prefer to wear warmer clothes rather than warming their rooms.

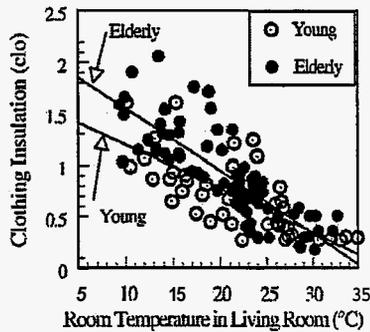
Figure 3 shows the relationships between living room temperature and clothing insulation. Significant linear relations were found for both the elderly ($r = -0.82, P < 0.01$) and the young ($r = -0.79, P < 0.01$).

Figure 3. Relationships between living room temperatures and clothing insulation.

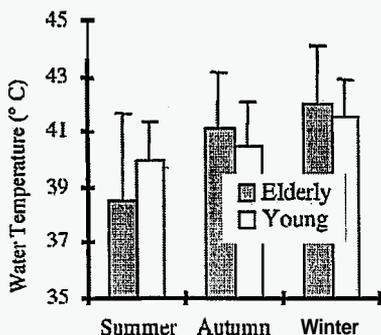
Figure 4 presents the temperature of bath in the three seasons. The mean (SD) of water temperature were 39.0 (3.2)°C for the elderly and 40.0 (1.4)°C for the young in summer, 41.1 (2.1)°C for the elderly and 40.5 (1.6)°C for the young in autumn, 42.2 (2.2)°C for the elderly and 41.5 (1.4)°C for the young in winter, respectively. A significant difference in water temperature was found among the seasons but not between the groups.

Figure 4. Water temperature of bath in the three seasons.

It is well known that Japanese prefer hotter baths than Americans or Europeans. In this study, the temperature of baths varied from about 39°C in summer to 42°C in winter (Figure 4). Significant relationships were found

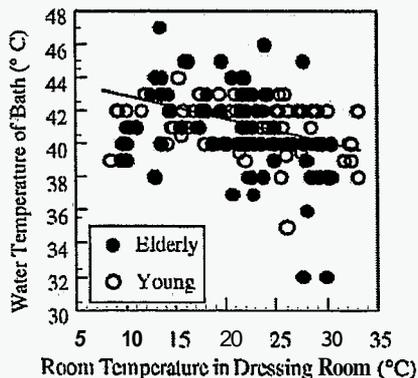
Figure 5 shows the relationship between the water temperature of bath and the air temperature in the dressing room. Although, there were significant linear relationships between them in both groups, no significant difference was found in the regression lines between the groups. A regression equation for the pooled

Figure 5. Relationships between dressing room temperature and temperature of bath.

data was calculated as $Y = -0.12X + 43.5$ ($r = -0.33$, $P < 0.01$), where Y is water temperature of bath in $^{\circ}\text{C}$; X is room temperature in dressing room in $^{\circ}\text{C}$.

between water temperature of bath and air temperature in the dressing room (Figure 5). Higher water temperature during showering was preferred when body temperature was low (8). Higher water temperature in winter might be due to Japanese habits but more likely due to insufficient bathroom heating in winter. The lower room temperature and the warmer bath water in winter create a steep temperature gradient that requires instant cardiovascular adjustments. This may increase the risk of adverse health effects and accidents among the elderly.
